Manhole Inspection Summary

Manhole # S06GG2016MH

Location Address: **3315 BONNIE RD** Cross Street: **BOXFORD RD**

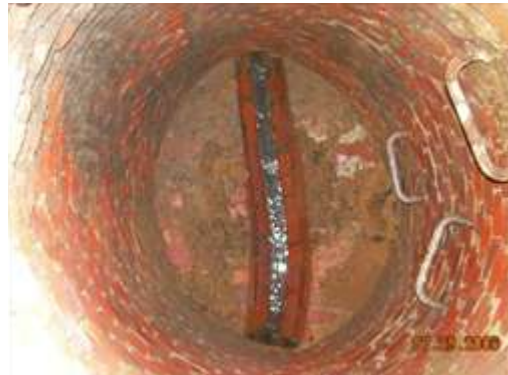
Top View

Adjustment, Corbel and Barrel infiltration.
Evidence of surcharge - Bench debris.
Corroded steps.

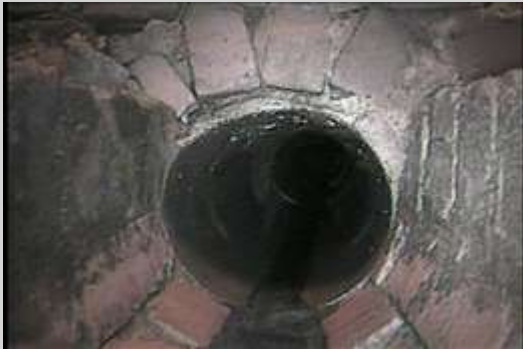
8 in. Circular Gravity Sewer Pipe Out @ 12 O'Clock

Barrel deterioration and infiltration.

Infiltration: **Evidence** Pipe Seal Cond: **Unknown**

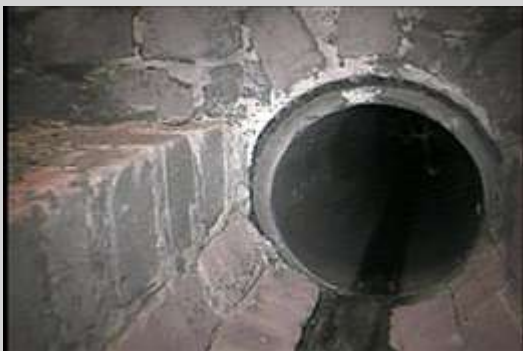
8 in. Circular Gravity Sewer Pipe In @ 6 O'Clock

Infiltration: **Evidence** Pipe Seal Cond: **Unknown**
